SCD

Case Study

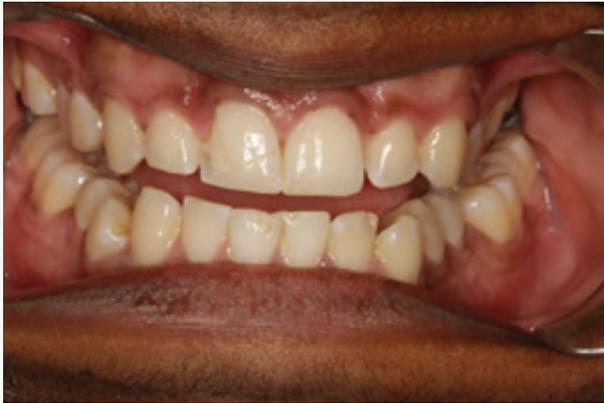
FIG. 1

The patient presented to the surgery after a football accident when he was knocked in the mouth (Fig. 1). The trauma and pain caused the patient to present to the local hospital for pain relief.

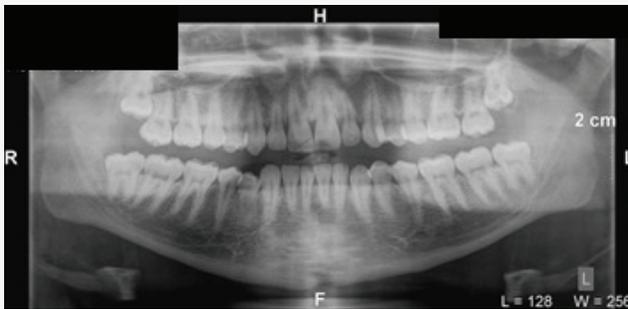
FIG. 2

Upon attendance at the surgery, the patient complained of severe pain and sensitivity to cold and air. On examination there was a crack in the tooth which had occurred at an angle and was inclined towards the root of the tooth. An OPG was taken (Fig. 2).

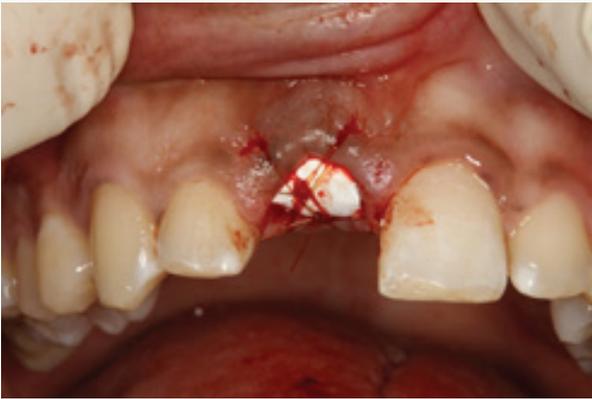
FIG. 3

The bone was prepared for placement of an implant into 11 socket. The implant placed was IA43-12d-13 4.3 mm X 13 mm TRI-NEX CO-AXIS 12 degree angled (LOT 084D04d2n02) which was torqued to 50Ncm. A 3.5 X 3.0 mm WIDE healing abutment was placed. Bio-Oss .25g graft was placed around the implant and into the socket to keep the ideal gum shape. The Bio-Oss and top of the implant were covered with Cytoplast™ GBR-200 membrane to help keep the bone graft material intact. The socket area was sutured to keep the membrane in place (Fig. 3).

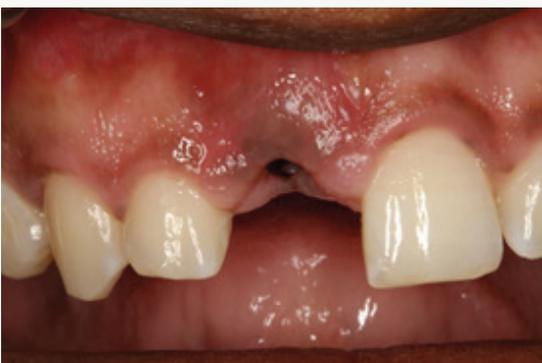
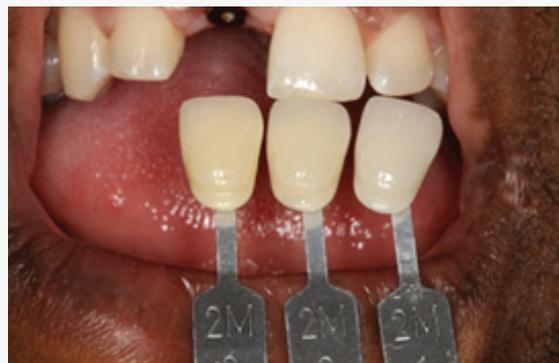
FIG. 4a

This was scheduled for 2 months after the implant had been placed (Fig. 4a and 4b).

An impression of the implant was done and no local anaesthetic was required. A shade was taken -2M1 2M2 2M3. The healing abutment was removed and a 3.5 mm impression coping was placed. The radiograph showed that all looked good. Upper and lower polyvinylsiloxane impressions were taken using AFFINIS® heavy and light body. The occlusal registration was taken using Blue Velvet for 30 seconds.

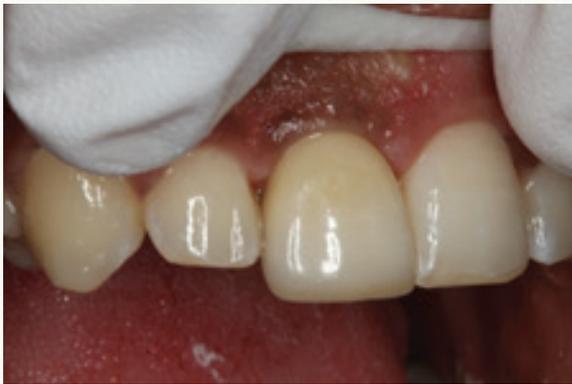
FIG. 5

Local anaesthetic was used Articaine 4% 1:100,000 Adrenalin 1 mls buccal infiltration palatal infiltration quadrant 1. The healing cap was removed and a temporary crown placed on 11 to 32Ncm (Fig. 5).

The access hole was filled using silicone tape. Metal primer Surpass® 2 and 3 (self-etching bonding system) and CLEARFIL MAJESTY™ Flow A2 G-aenial™ P-A2. The occlusion was checked, adjusted and polished. Post-operative Panadol was advised.

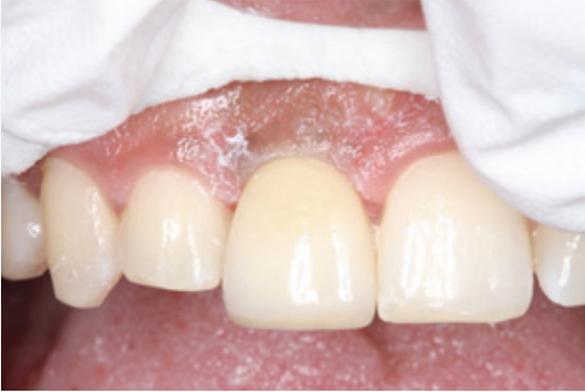
FIG. 6

The shape of the crown was evaluated at the beginning of the visit. The patient and the dentist were happy with the shape and shade of the crown. The new implant abutment crown was screwed in to 35Ncm and the crosspin tightened (Fig. 6).
